F-1-189
John P. Graff Farmstead; "Clifton on the Monocacy" 1889-ca. 1945
Buckeystown vicinity
Private

F-1-189 John P. Graff Farmstead Buckeystown Frederick County

Maryland Historical Trust State Historic Sites Inventory Form

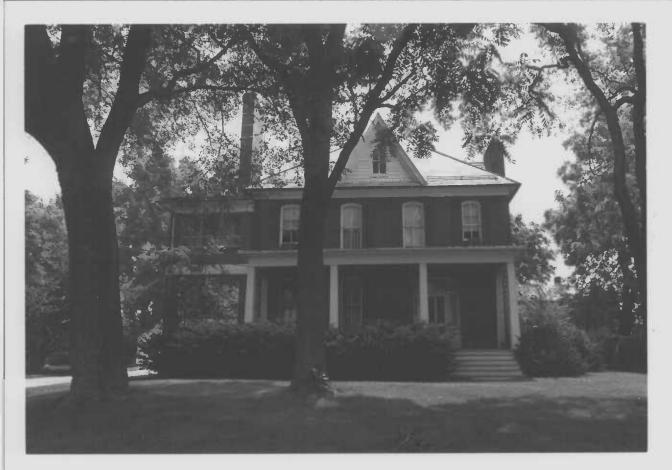
F-1-189 John P. Graff Formstead Frederick County Photo: Janet Davis June 1993 Neg. loc. Md. SHPO, Crownsville, Md West elevation

The main dwelling has an irregular number of bays on the west elevation, with three bays on the first story and four on the second story. A central cross gable with a shingled face and a round-arched 2/2 window breaks the hipped roof of slate. Shingled gables also are on the north and south roof slopes, the north gable beir visible above the 1940's addition on that side. Four chimneys are located near th central ridge of the roof. One near the northwest corner has been raised in The brick walls are 7:1 American bond. A one-story porch extends across the west elevation, with square paneled piers. The window and door openings have segmental arches. The sash is 2/2 with louvred shutters. The doorway has a transom and sidelights. Fluted columns flank the doorway. The south elevation has a staggered window pattern, reflecting the location of the interior stairway. A two-story rear wing extends from the northeast corner. It has a two-story open porch on the south side, the upper level of which is enclosed with screens. A scroll-sawn balustrade is visible through the screens. The interior of the house retains much of the original stained wood trim at the stairway, door, and window The kitchen has a painted wall mural by a German prisoner of war who was on farm labor detail at Clifton during the period about 1943-1945. The artist re-visited the Thomases after the war accompanied by his family and remained friends for many years thereafter.

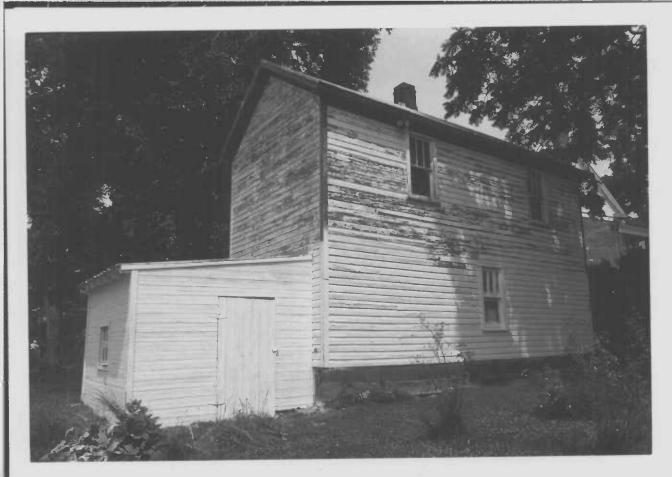
F-1-189 John P. Graff Formstead Frederick County Photo Jonet Davis JUNE 1993 Neg. low Md. SHPO, Crownsville Md. Summer Kitchen, Southeast corner view 3/7

Summer kitchen: The frame summer kitchen was probably built about 1889 along with the main house. It is a two-story structure located southeast of the rear wing. The exterior is covered with german siding and the roof with corrugated metal. A center chimney rises above the roof. The north elevation has a paneled door and a 3/1 window on the second level. The east and west elevations have two bays with 3/1 sash. A one-story shed addition is on the south elevation. According to Mrs. Thomas, the summer kitchen was used as living quarters by farm laborers and occasionally by the German POW's detailed to Clifton for farm work.

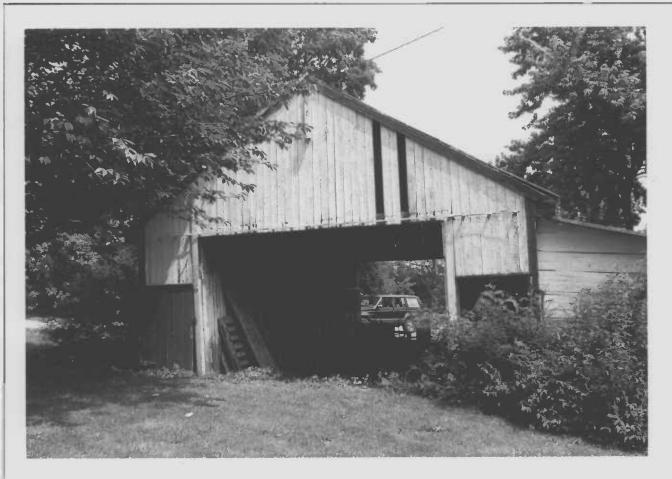
F1-189 John P. Groff Formstead Frederick County Ploto: Jonet Davis June 1993 Neg. loc. Md. SHro, Crownsville, Md. Wagon shed /corn crib south elevation 4/7

Wagon shed/corn crib: The frame wagon shed with corn cribs was built about 1890 and has vertical siding and a standing seam metal roof. The east and west sides of the shed have horizontal siding. On the east elevation is an open-sided shed facing east, probably an addition of the early 20th century. The wagon shed is located east of the main house at right angles to the bank barn ramp.

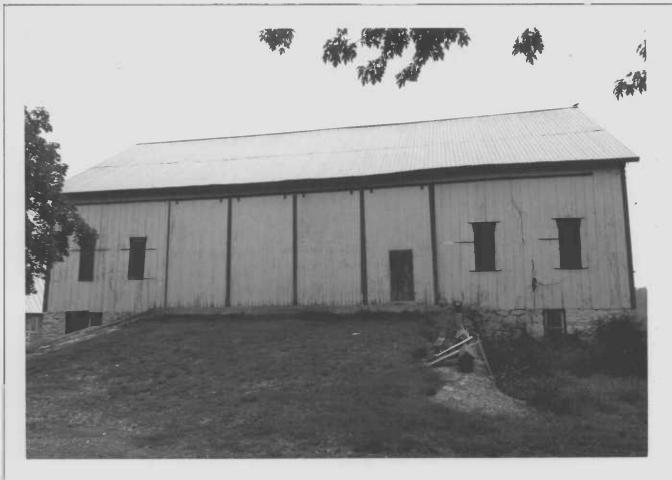
E-1-189 John P. Groff Formstead Frederick County Photo: Janet Davis June 1993 Neg. 100: Md. SHPO. Crown = ville, Md. Bonk born, west elevation 5/7

Bank barn: The frame bank barn was also built about 1890, with vertical siding and louvred vents with scroll-sawn frames. The exterior is painted white. The roof is corrugated metal. The stall level is partially enclosed on the east side.

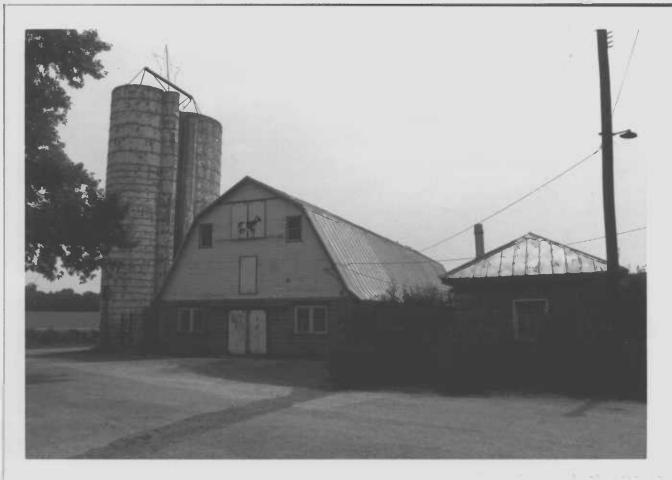
F-1-189 John P. Groff Formstood Frederick County Photo: Jonet Davis June 1993 Neg. loc. Md. SHFO, Crownsville, Md. Dairy born & milk house, view from west 6/1

Dairy barn and milk house: The dairy barn and milk house are rusticated concrete block. The milk house has a hipped standing seam metal roof, with 6/6 windows and tongue-and-groove doors. The quoins are slightly lighter in color than the rest of the concrete blocks. The dairy barn has a standing seam metal gambrel roof. On the east end is an extension of plain concrete block, an alteration of the early 1950's. Two non-contributing concrete silos are located north of the barn. The date of the barn and the milk house is probably the early 1940's, but this could not be confirmed by Mrs. Thomas.

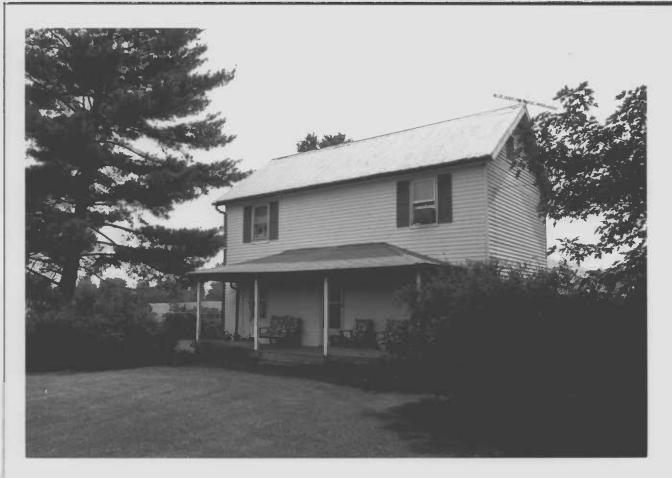
F=1-189 John P. Groff Formstead Frederick County Photo: Jonet Davis June 1993 Neg. loc: Mid. SHPO, Crownsville, Md. Terant house, west elevation 7/7

Tenant house: The tenant house is a two-story frame building with vinyl siding, 2/2 sash, and a standing seam metal roof. A two-story shed addition is on the east side of the house. The west elevation has three bays on the first story under a one-story porch and two bays on the second. The house was moved from a more distant site northeast of the main grouping in about 1945. It was probably originally built about 1889-1890.
